**PRELIMINARY GEOTECHNICAL ENGINEERING STUDY
PROPOSED RESIDENTIAL PLAT
4135 - 332ND AVENUE SOUTHEAST
KING COUNTY (FALL CITY), WASHINGTON**

ES-6990

**PREPARED FOR
CORY BRANDT GROUP**

December 11, 2019

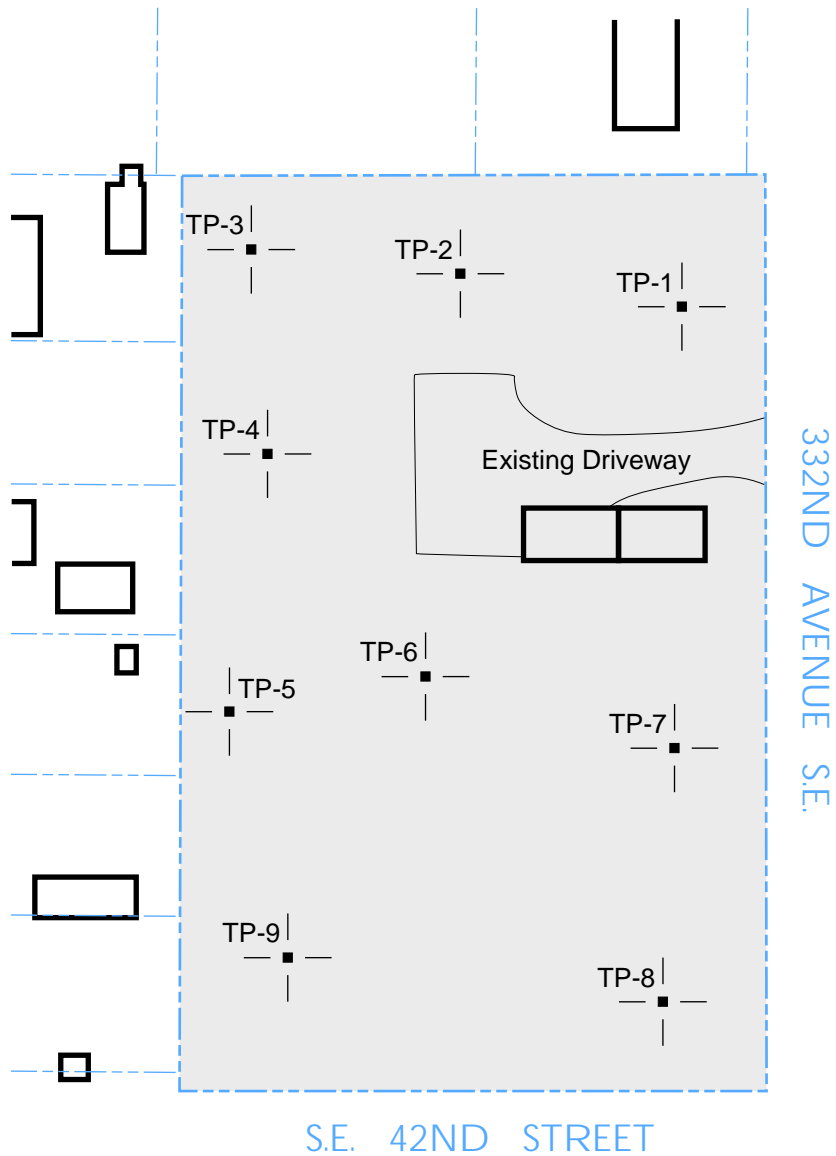
Earth Solutions NW_{LLC} Geotechnical Engineering, Construction Observation/Testing and Environmental Services	
Test Pit Location Plan Fall City 332nd King County (Fall City), Washington			
Drwn.	CAM	Date	11/08/2019
Proj. No.	6990	Checked	SES
Date	Nov. 2019	Plate	2

TP-1 | — ■ — |
 |
 |
 Approximate Location of
 ESNW Test Pit, Proj. No.
 ES-6990, Oct. 2019

Subsurface conditions at the subject site were explored on October 22, 2019 by excavating nine test pits using a trackhoe and operator retained by our firm. The approximate locations of the test pits are illustrated on Plate 2 of this study. The test pit logs are provided in this Appendix. The test pits were advanced to a maximum depth of approximately 13 feet bgs.

An ESNW representative observed, logged, and sampled nine test pits, excavated at accessible locations within the property boundaries, on October 22, 2019, using a trackhoe and operator retained by our firm. The test pits were completed to assess and classify site soils as well as to characterize groundwater conditions within accessible areas of the site. The approximate locations of the test pits are depicted on Plate 2 (Test Pit Location Plan). Please refer to the test pit logs provided in Appendix A for a more detailed description of subsurface conditions. Representative soil samples collected at the test pit locations were analyzed in accordance with both Unified Soil Classification System (USCS) and USDA methods and procedures.
